Manhole Inspection Summary

Manhole # S07UU1003MH

Insp Date: **10/12/06 2:30 PM**

Location Address: **5602 W NORTHERN PKWY**

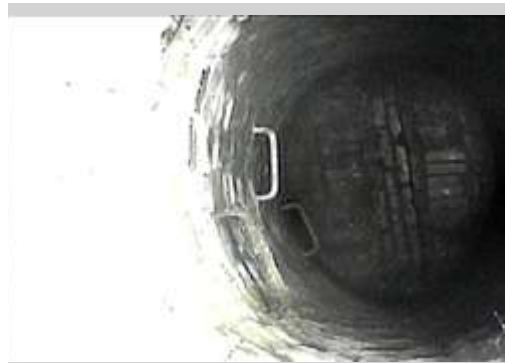
Top View

Bench debris.

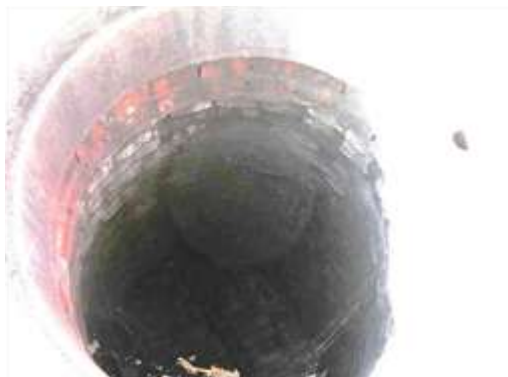
Defect

Frame leaks. Adjustment loose brick. Adjustment and Corbel infiltration.

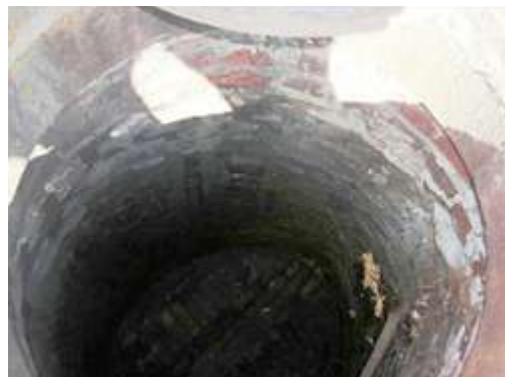
Defect

Frame leaks. Adjustment loose brick. Adjustment and Corbel infiltration - other side.

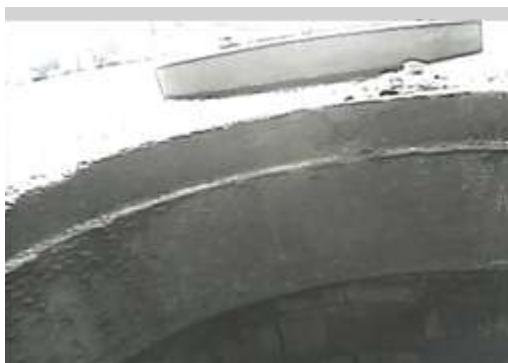
Defect

Frame leaks. Adjustment deterioration, loose brick, and infiltration.

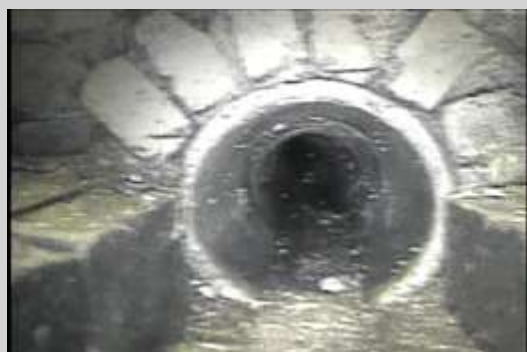
Pipe Out @ 12 O'Clock

Deposits: ☐ None ☒ **Mud** ☐ Sludge ☒ **Debris** ☐ Grease

Infiltration: **Evidence** Pipe Seal Cond: **Unknown**

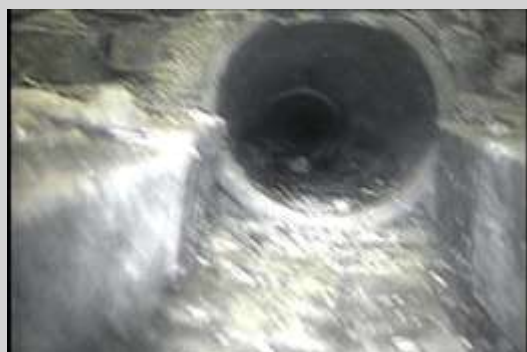
Pipe In @ 6 O'Clock

Deposits: ☐ None ☒ **Mud** ☐ Sludge ☒ **Debris** ☐ Grease

Infiltration: **Evidence** Pipe Seal Cond: **Broken**
